## Development of Habitat Enhancement Alternatives for the Teichert Hallwood Facility and Adjacent Areas, Lower Yuba River

cbec, inc.

**DEVELOPMENT OF HABITAT ENHANCEMENT ALTERNATIVES FOR THE  
TEICHERT HALLWOOD FACILITY AND ADJACENT AREAS,  
LOWER YUBA RIVER**

**FINAL REPORT**

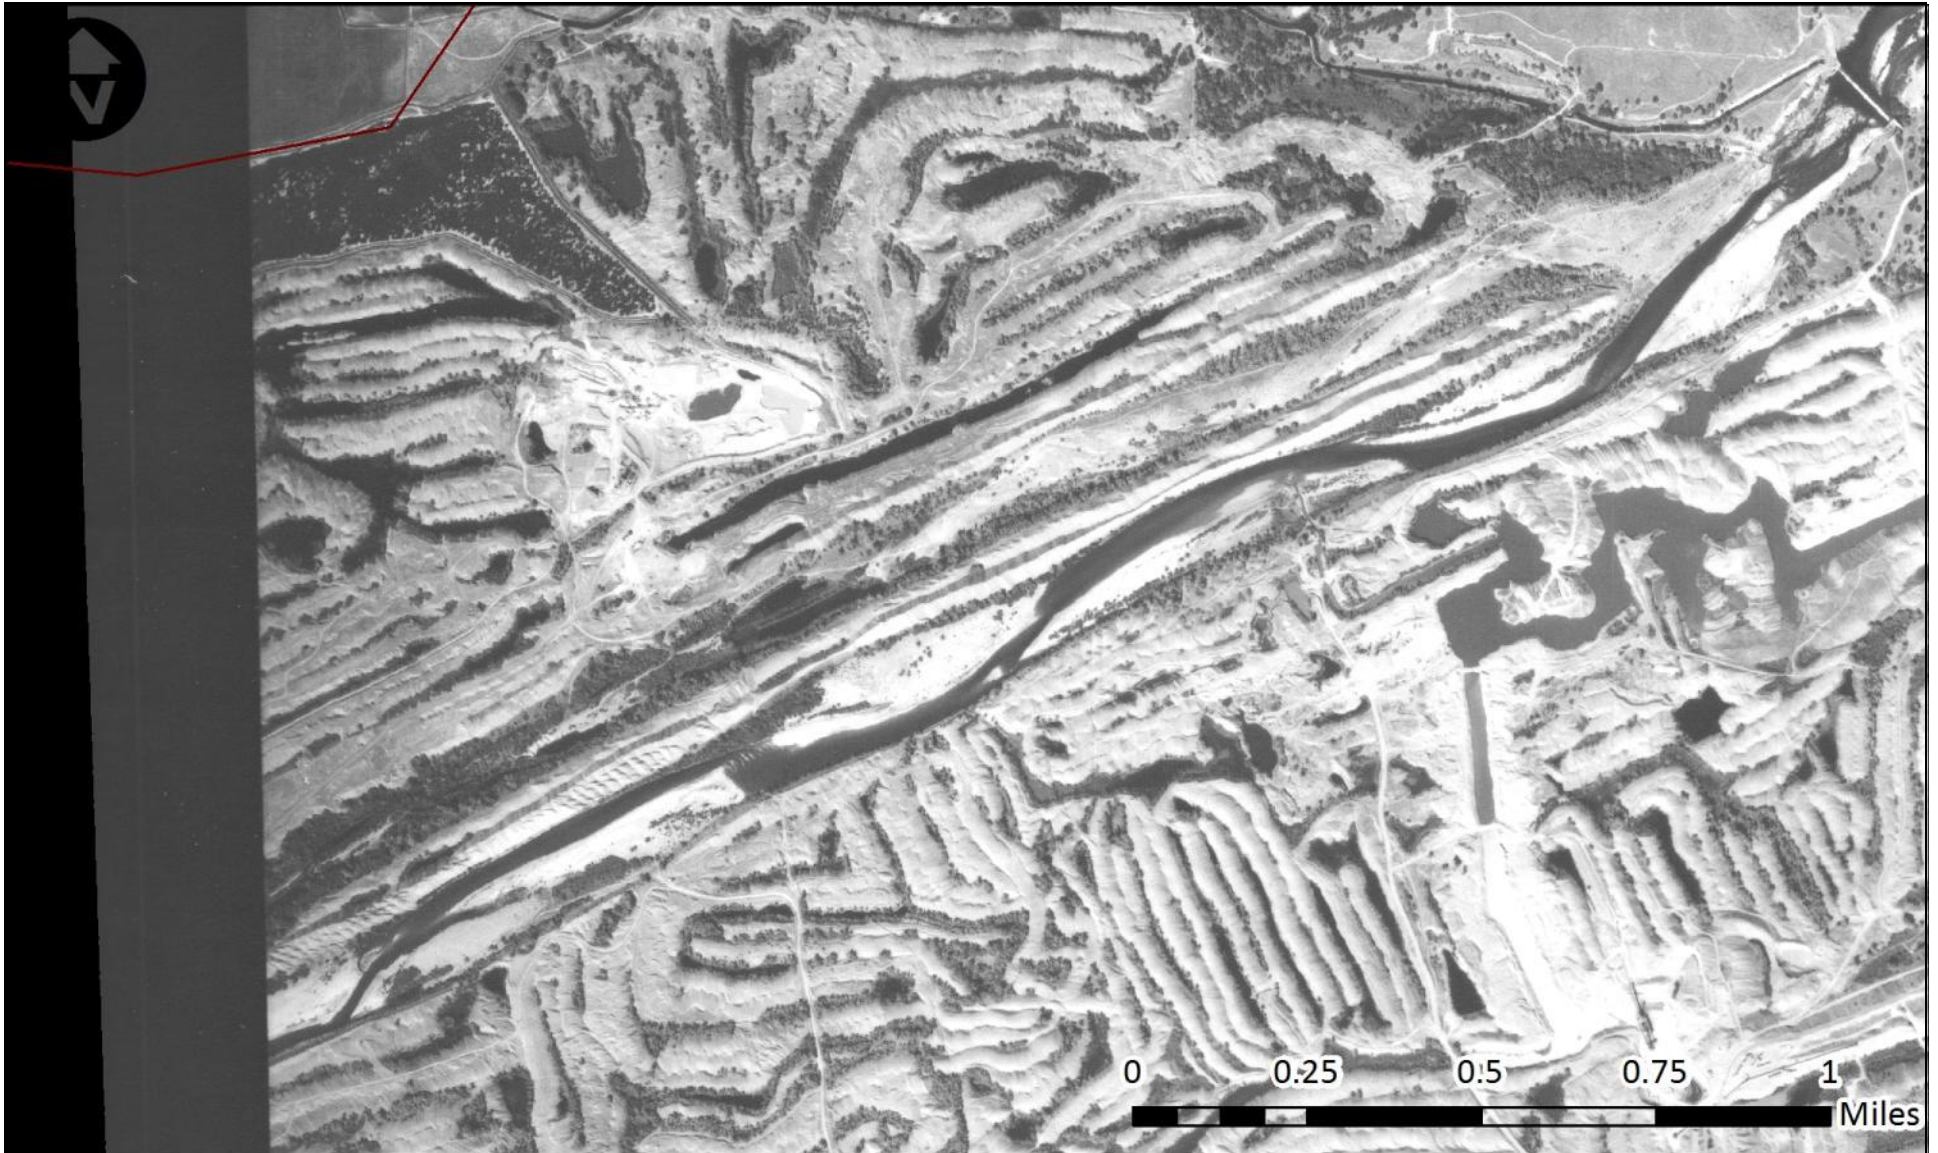
**Figure 8**

Notes: Aerial image from James (2012). See Figure 2 for hydrologic time series. Flight date of 11/4/1986 at flow of approximately 830 cfs.

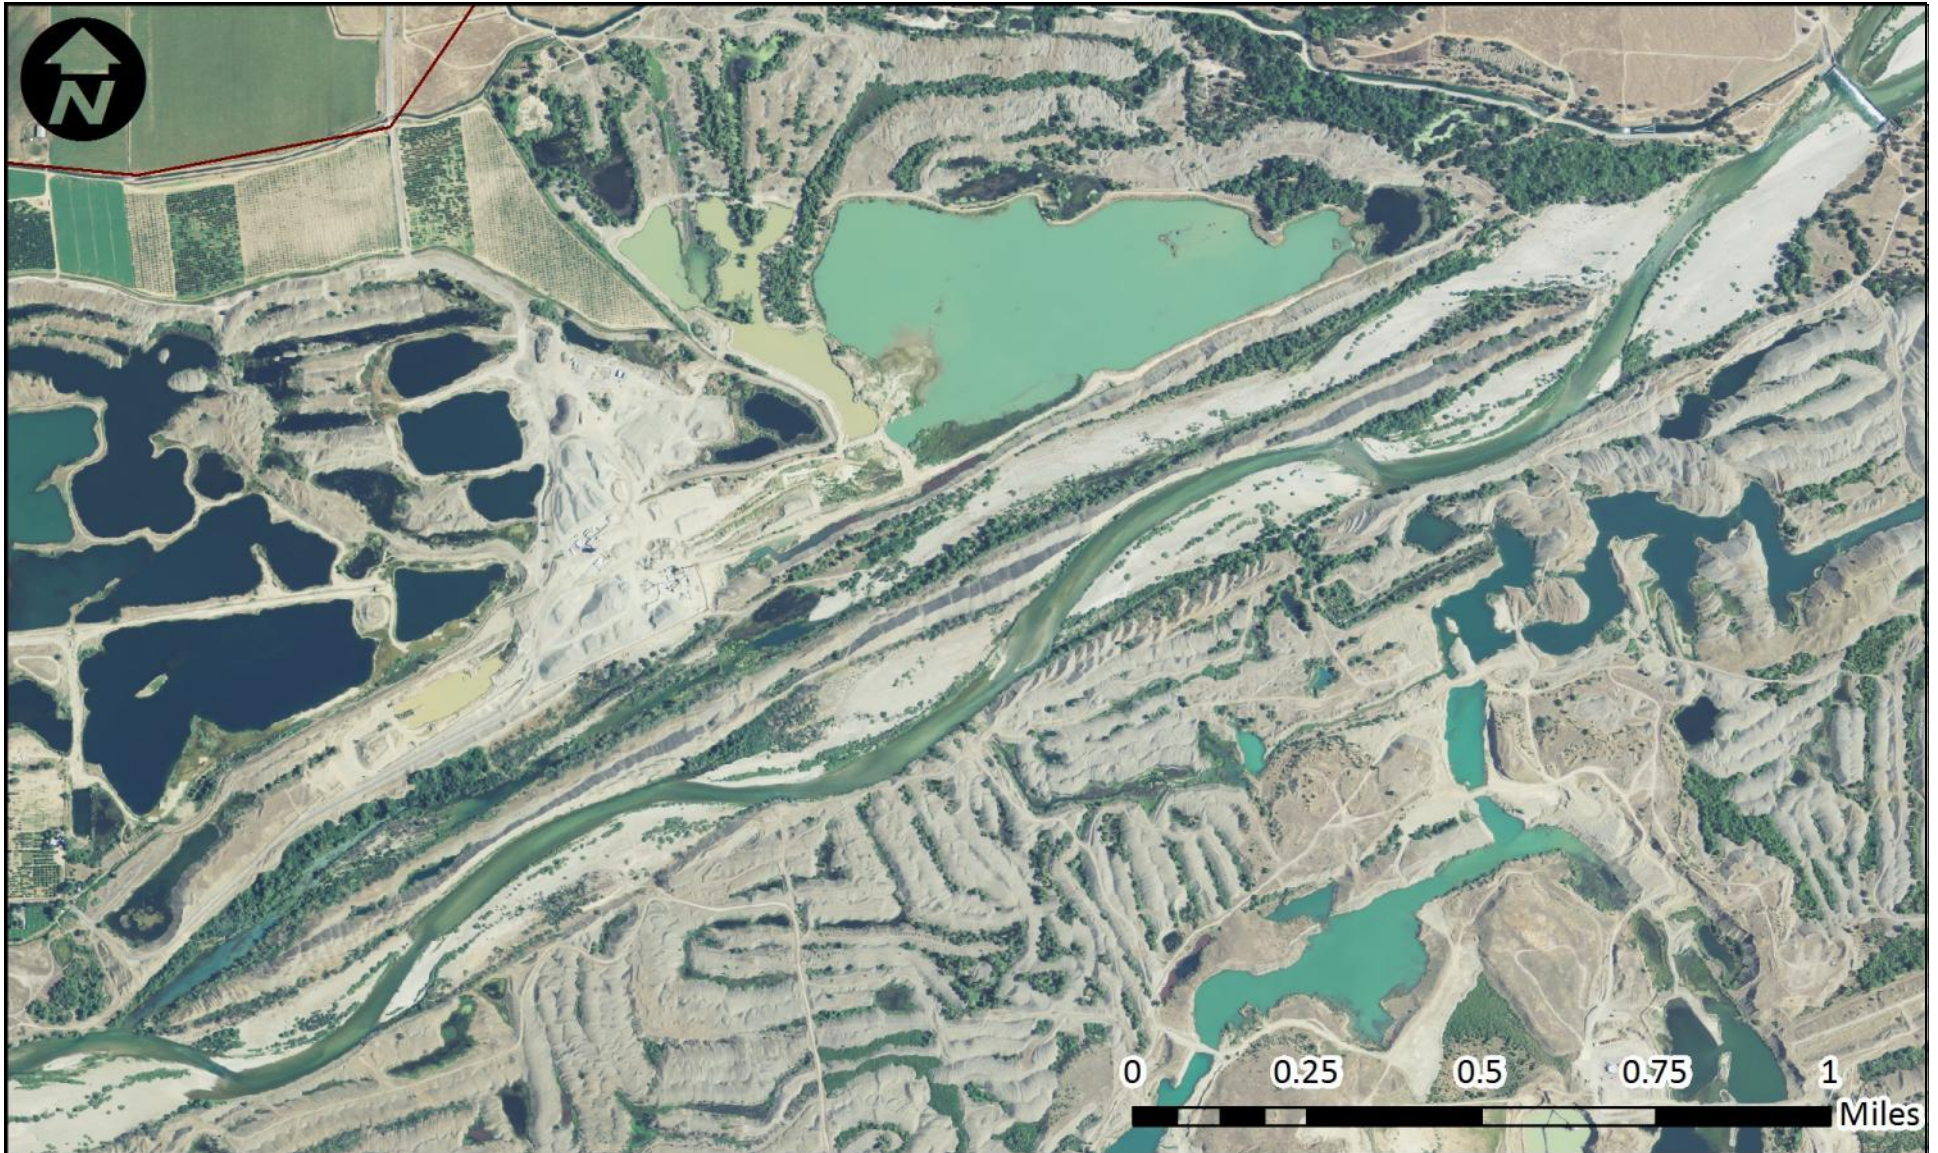
**Figure 10**

Notes: Aerial image from James (2012). See Figure 2 for hydrologic time series. Flight date of 7/3/2009 at flow of approximately 1,987 cfs.

- Between 1999 and 2009, main channel meanders exhibited additional lateral extension and minor downstream translation (Figures 9, 10 and 11). The 2009 aerial also shows conditions during the data collection period for the 2D modeling efforts as well as current land uses north of the river.

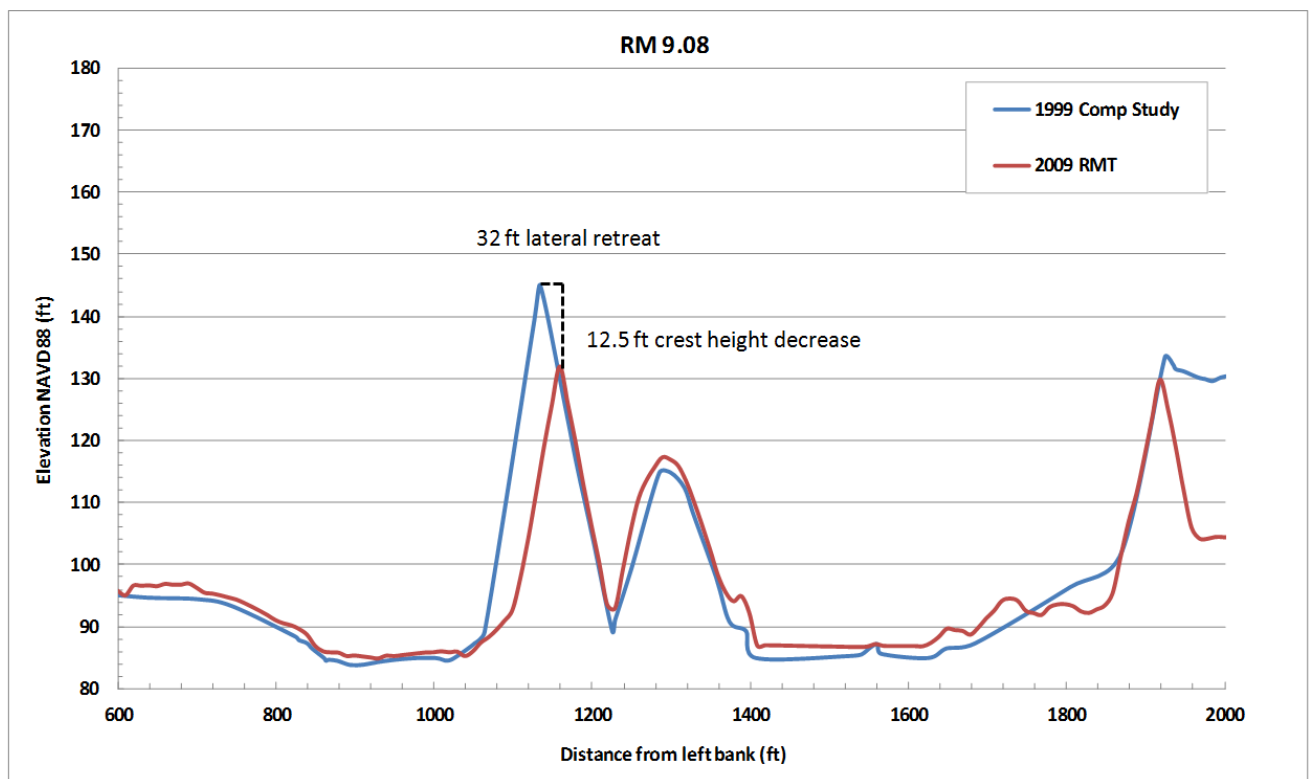
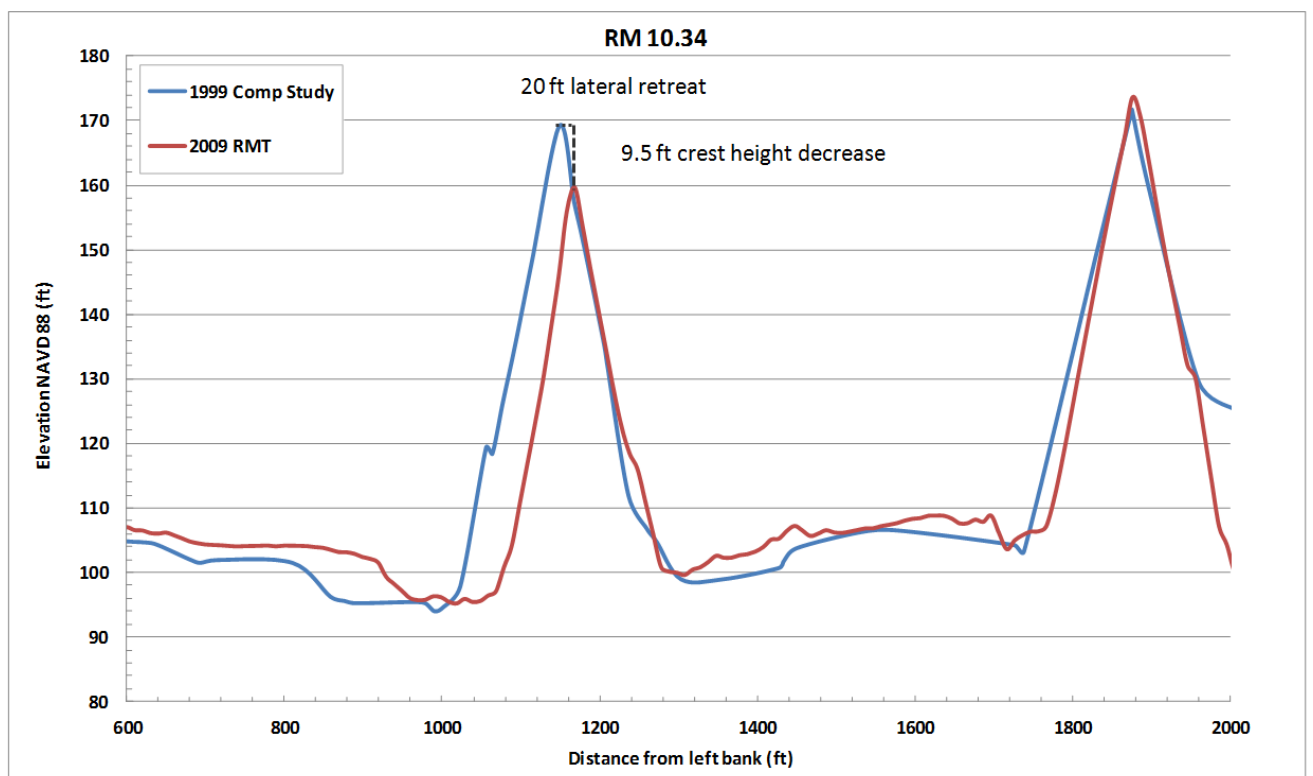
Notes: Cross sections at approximate apex of main channel river right meander bends in DPD reach

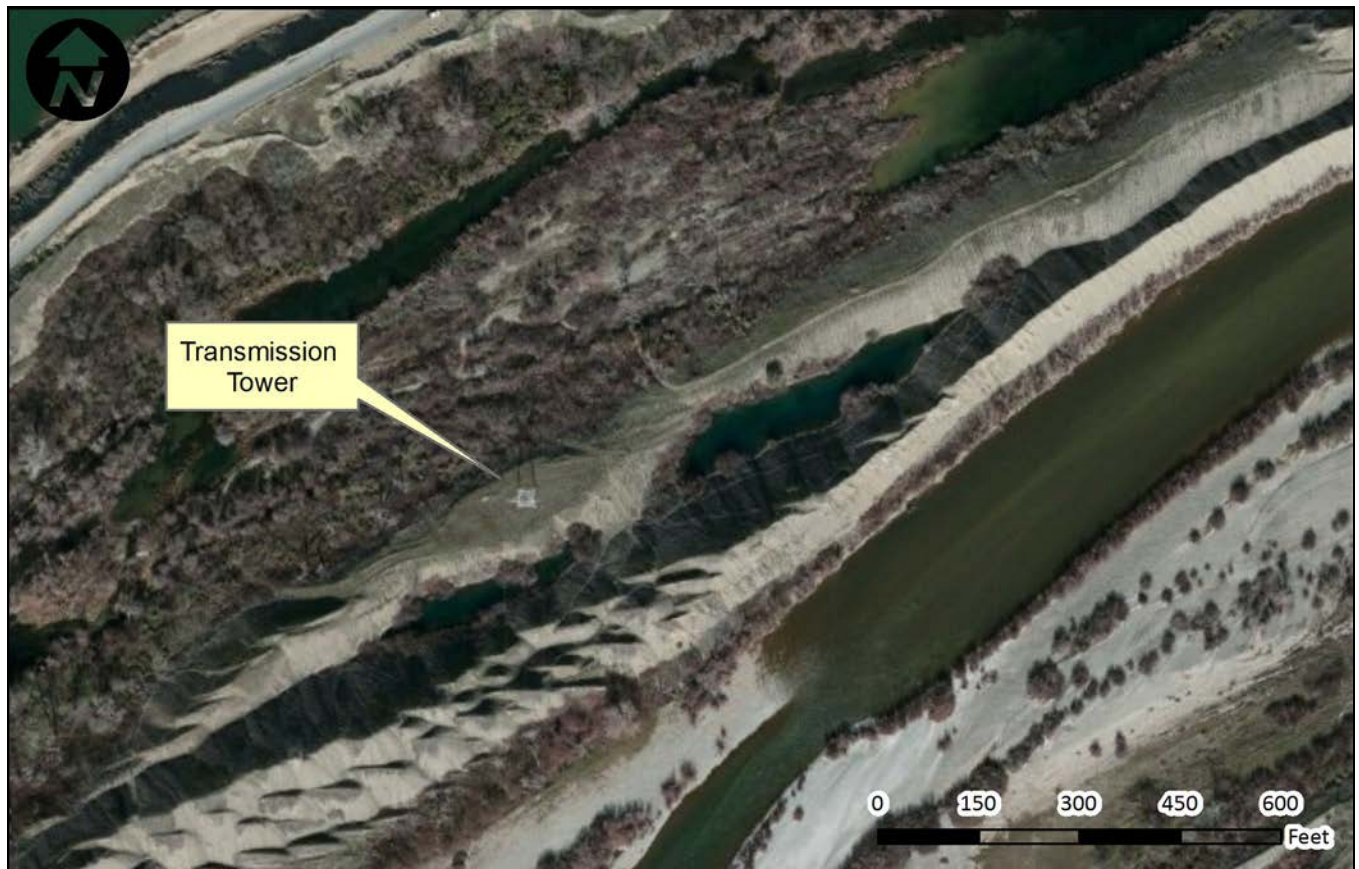
<i>Hallwood Off-Channel Habitat Enhancement Alternatives, Lwr. Yuba River</i> <b>Middle wall transmission tower</b>		
		Project No. 12-1034	Created By: JDS	<b>Figure 18</b>

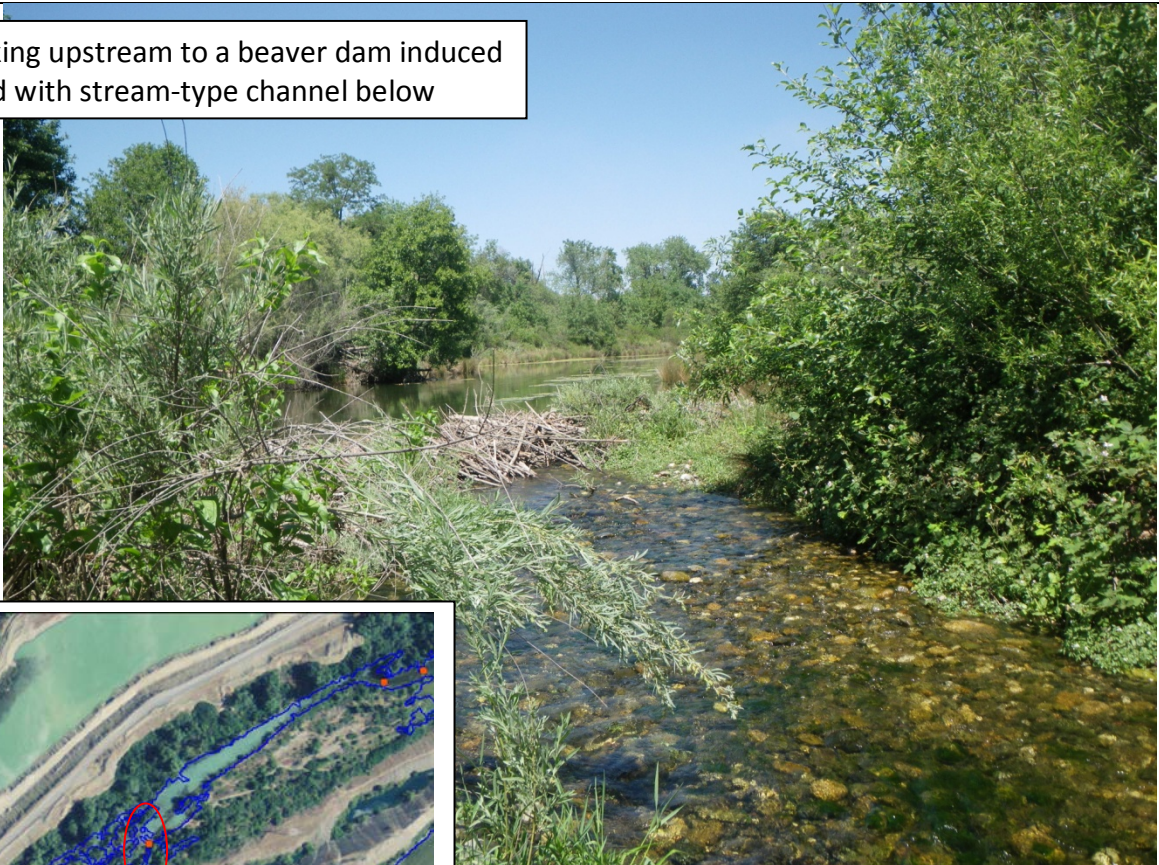
**Figure 22**

Looking upstream to a beaver dam induced pond with stream-type channel below

Looking upstream in stream-type channel

Notes: Photos taken by A. Sawyer 05/02/13.

Several reference sites along the LYR may also help guide design. A side channel at First Island in the Parks Bar Reach (upstream of the DPD reach) demonstrates bankfull widths from 75 - 125 feet according to the RMT 2D model results (Pasternack, 2009). Existing stream-type features within the high-flow channel corridor may also provide a good baseline for stream-type side channel geometry. When supplied by subsurface flows, their widths range between 20 and 40 feet but would grow with a greater amount of flow. An example of a stream-type side channel in the project area is shown in Figure 22.

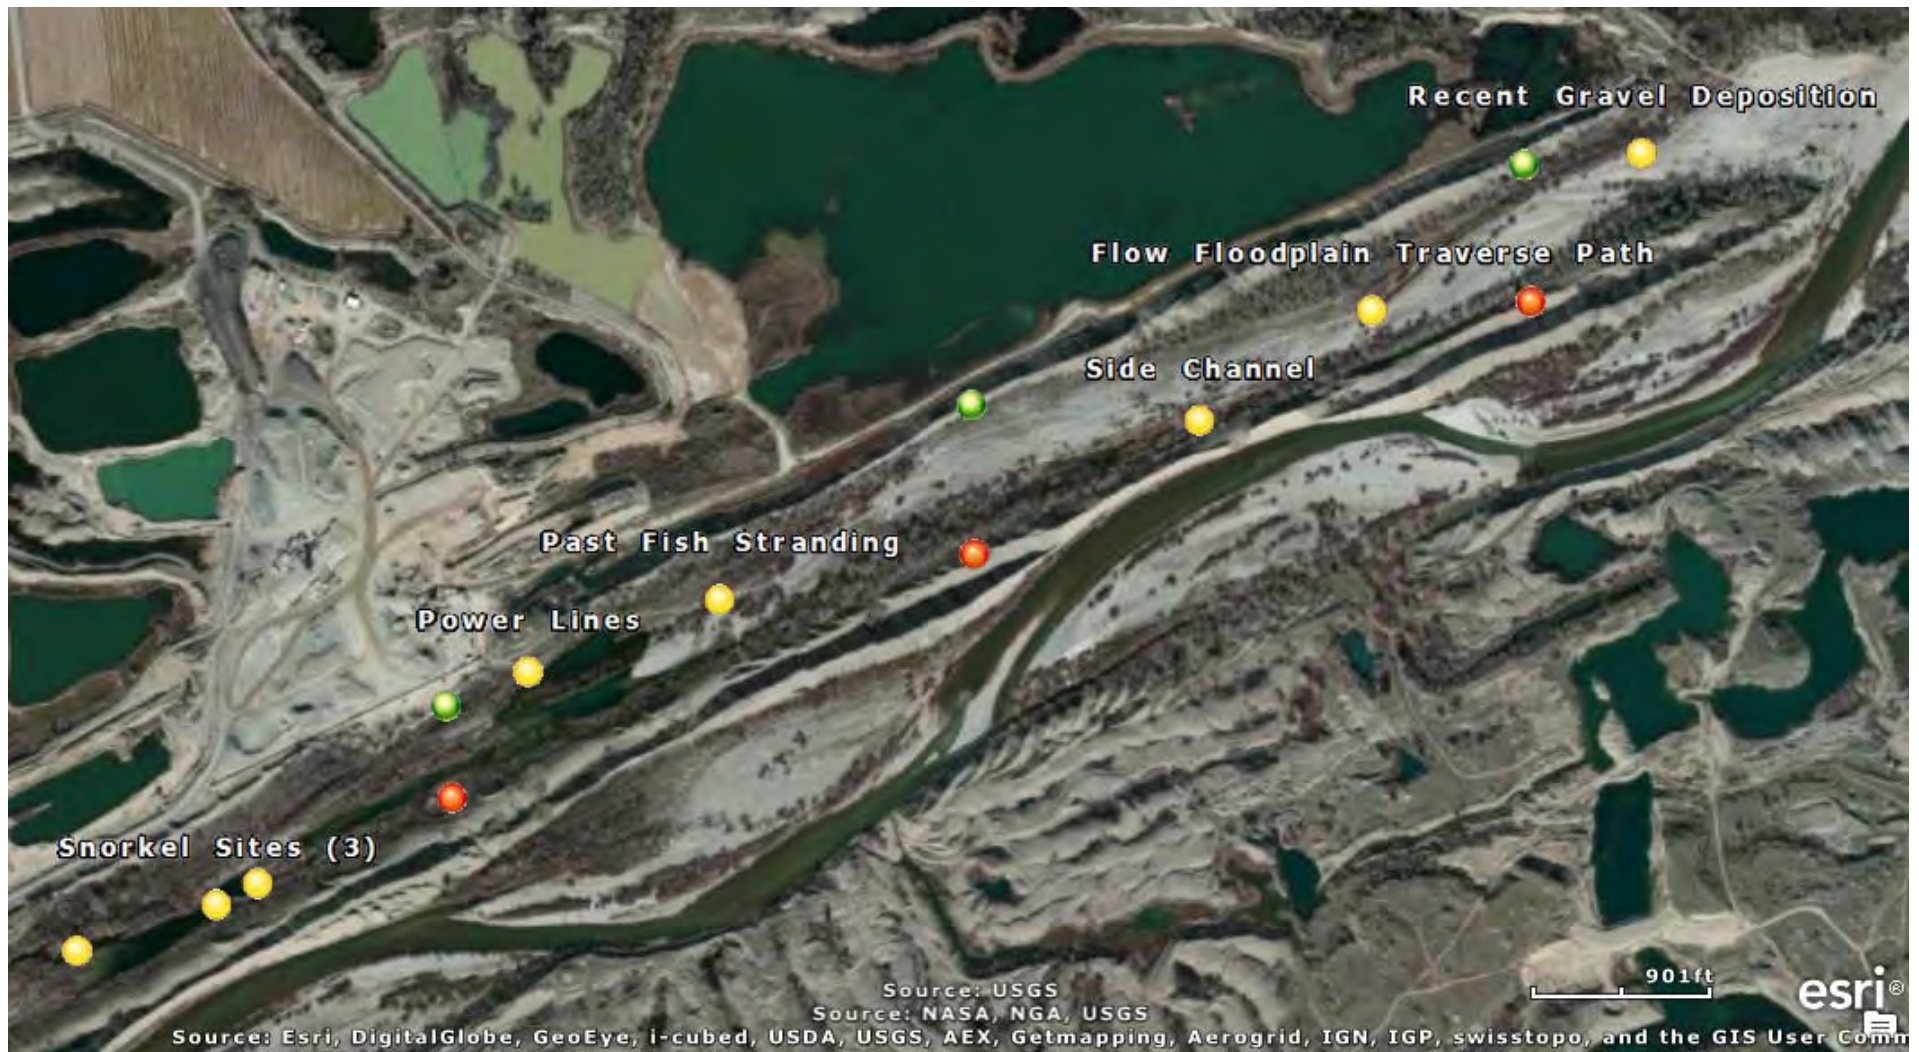
Figure 1. Sites and features of the Teichert Hallwood Plant property, lower Yuba River, visited and discussed in view of potential fish habitat restoration on April 15 and May 8, 2013. The area of interest is the floodplain, which is bounded by the north training wall indicated by the line of three green spheres, and middle training wall indicated by the line of three red spheres.

The Teichert Hallwood Plant manager took this group on a more extensive tour of the Hallwood property from the Hallwood Plant access near the power lines upstream (the likely location of potential habitat restoration activities) to the location of high flow entrance into Daguerre Alley near Daguerre Point Dam. The manager indicated that Hallwood Plant-based conveyors could potentially be used to assist with substrate removal for habitat restoration. Specifically, conveyors could be moved to a restoration site and installed within approximately two weeks. About 1-2 M tons of substrate per year could be removed and processed either from the floodplain or middle training wall. Feasibility of assistance with habitat restoration from mining activities would depend in part on demand for the product. The manager identified typical floodplain inundation flow patterns, and locations where he had observed fish stranding and gravel erosion and deposition related to inundation events (Figure 1). He indicated that coyote, deer, garter snake, and great blue heron often were observed on the Hallwood Plant property.

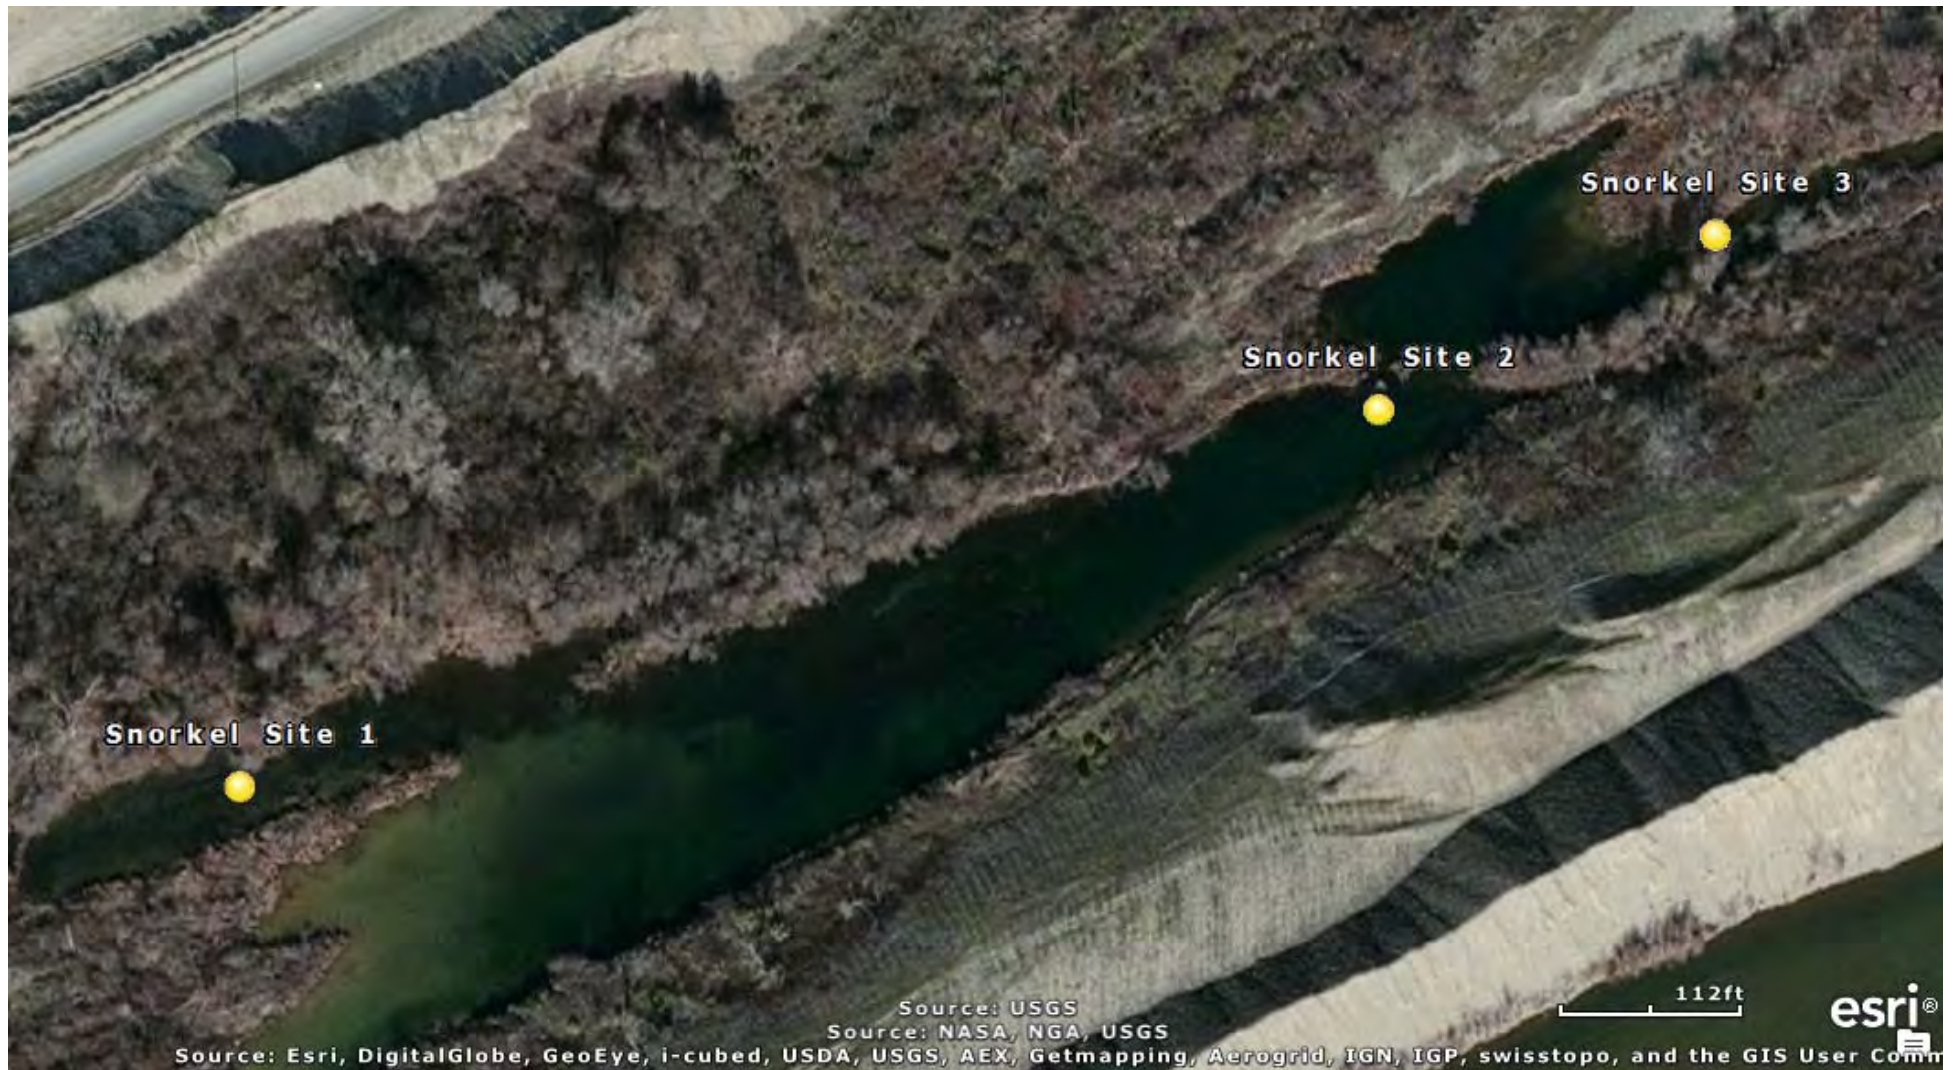
Figure 2. Three snorkel sites surveyed for fish on April 15, 2013 on the Teichert Hallwood Plant property, lower Yuba River, California.

Recent observations have been made of Chinook salmon, steelhead, California roach and Sacramento sucker in existing side channel habitat features of the high-flow channel corridor. In April 2013, U.S. Fish and Wildlife Service (USFWS) and SYRCL personnel snorkeled three side channel sites in a portion of the downstream section of the high-flow channel (see Appendix A for Campbell (2013) report). They observed numerous juvenile Chinook salmon at all three sites along with steelhead, yearling Chinook salmon and other fish species in various combinations by site. The fish sightings as well as descriptions of habitat, bed substrate, terrestrial wildlife and water temperature are described in detail in the full site visit report located in Appendix A.
